United States Department of the Interior
National Park ServiceNational Register of Historic Places
Registration Form

historic name Johnson, Wilbur T. and Rhoda Stephens, House
other names/site number Missouri State DAR Headquarters
Roslyn Heights, 0-32

street & number 821 Main N/A not for publication
city, town Boonville N/A vicinity
state Missouri code MO county Cooper code 053 zip code 65233

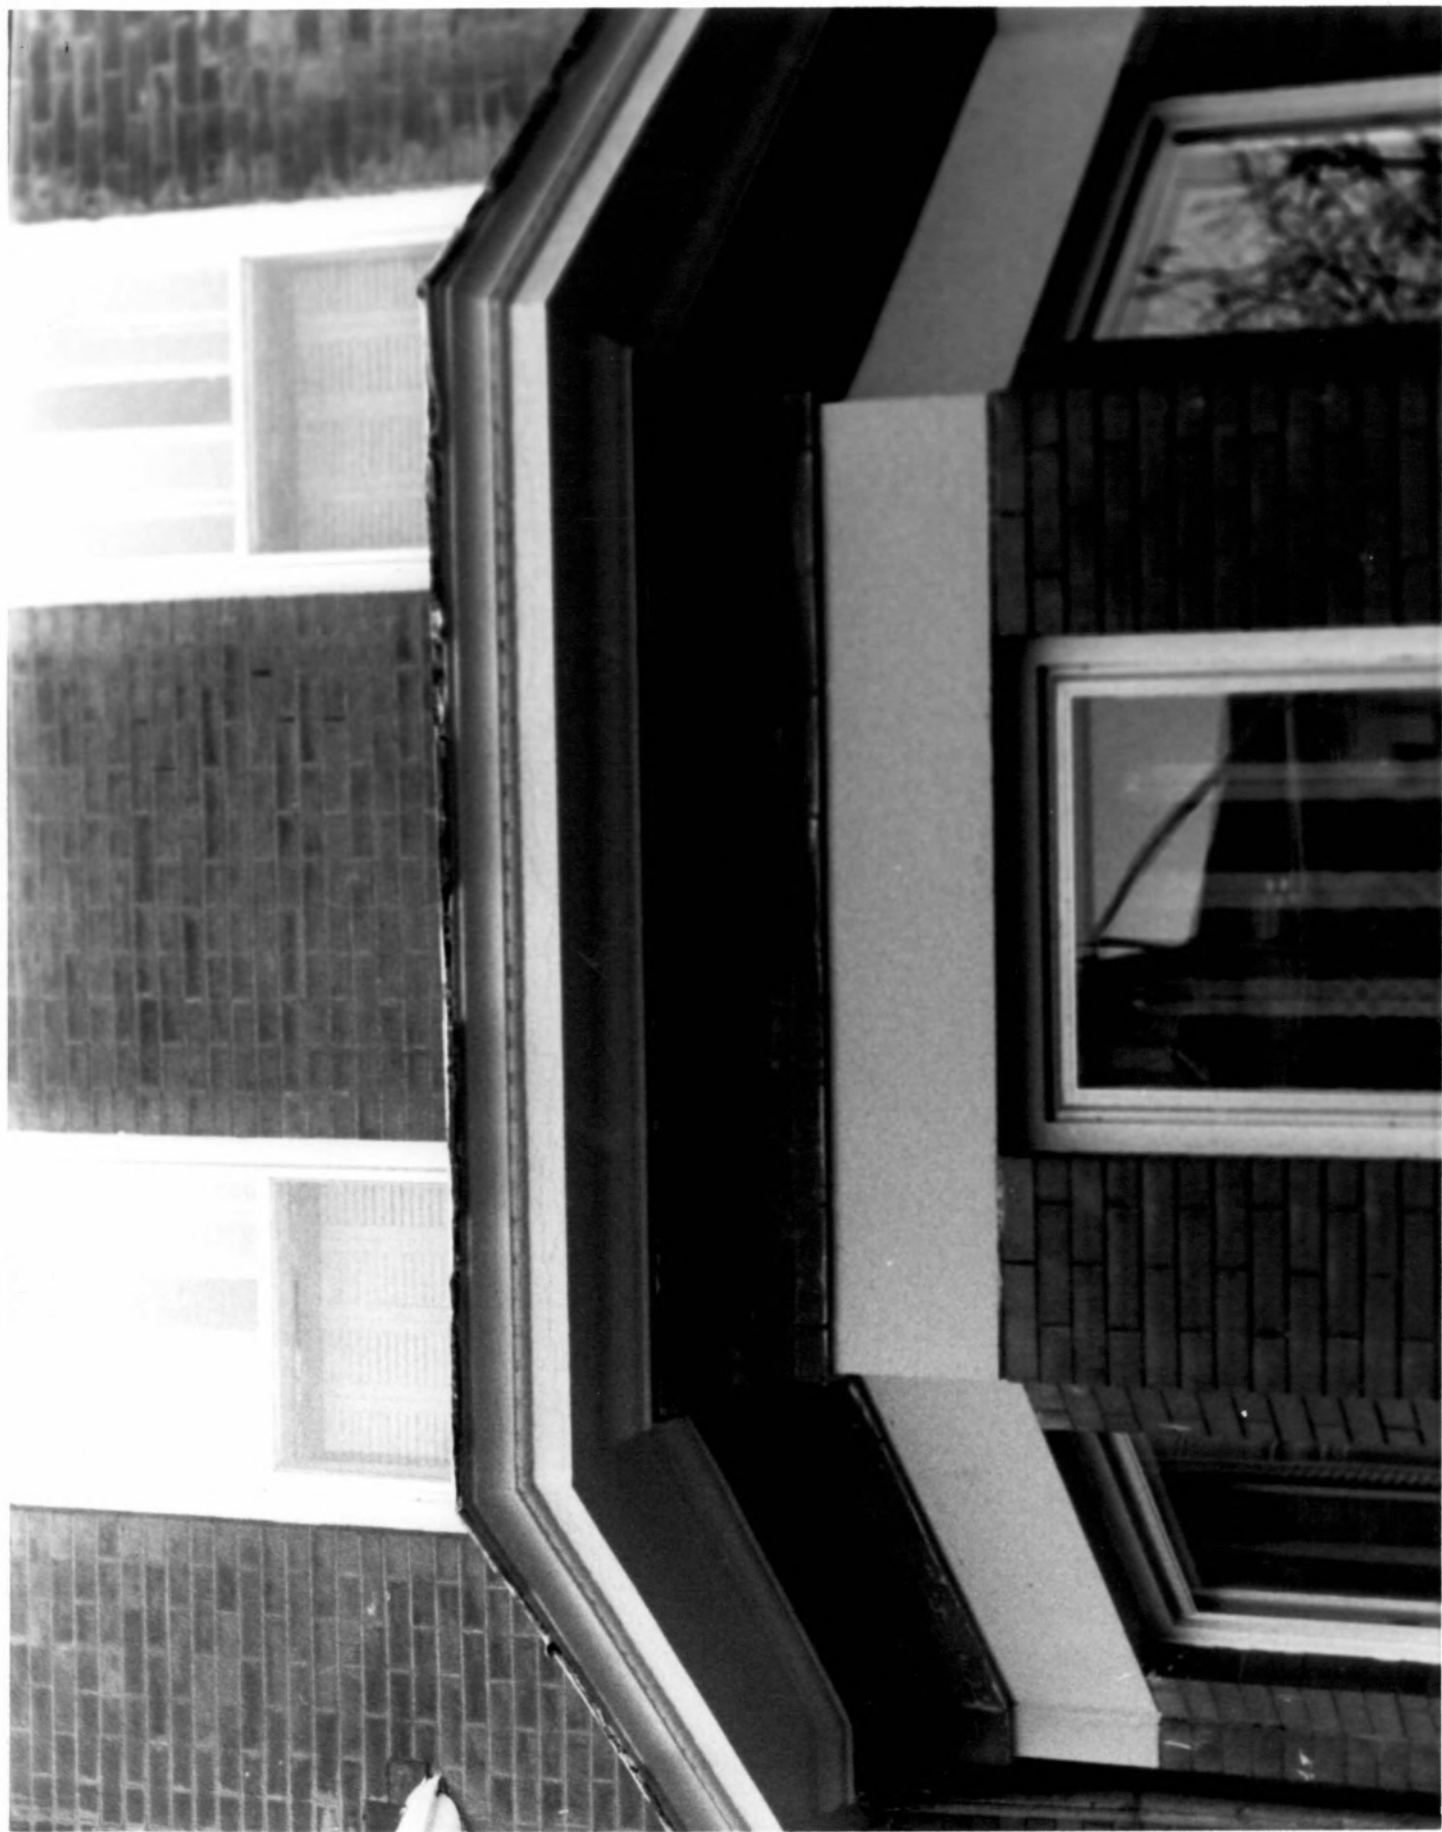
Roslyn Heights
Boonville, Missouri
Maryellen H. McVicker
January 10, 1987
DAR Headquarters at House
Section of Bay Window on North
Facade

Interesting features on the north elevation include an oriel window with a corbelled brick base and a one-story polygonal brick bay window. The second floor, as on the east elevation, has plain windows with stone lintels and lug sills. This elevation possesses a gabled dormer identical to the facade dormer. A corbelled brick chimney rises next to the tower.

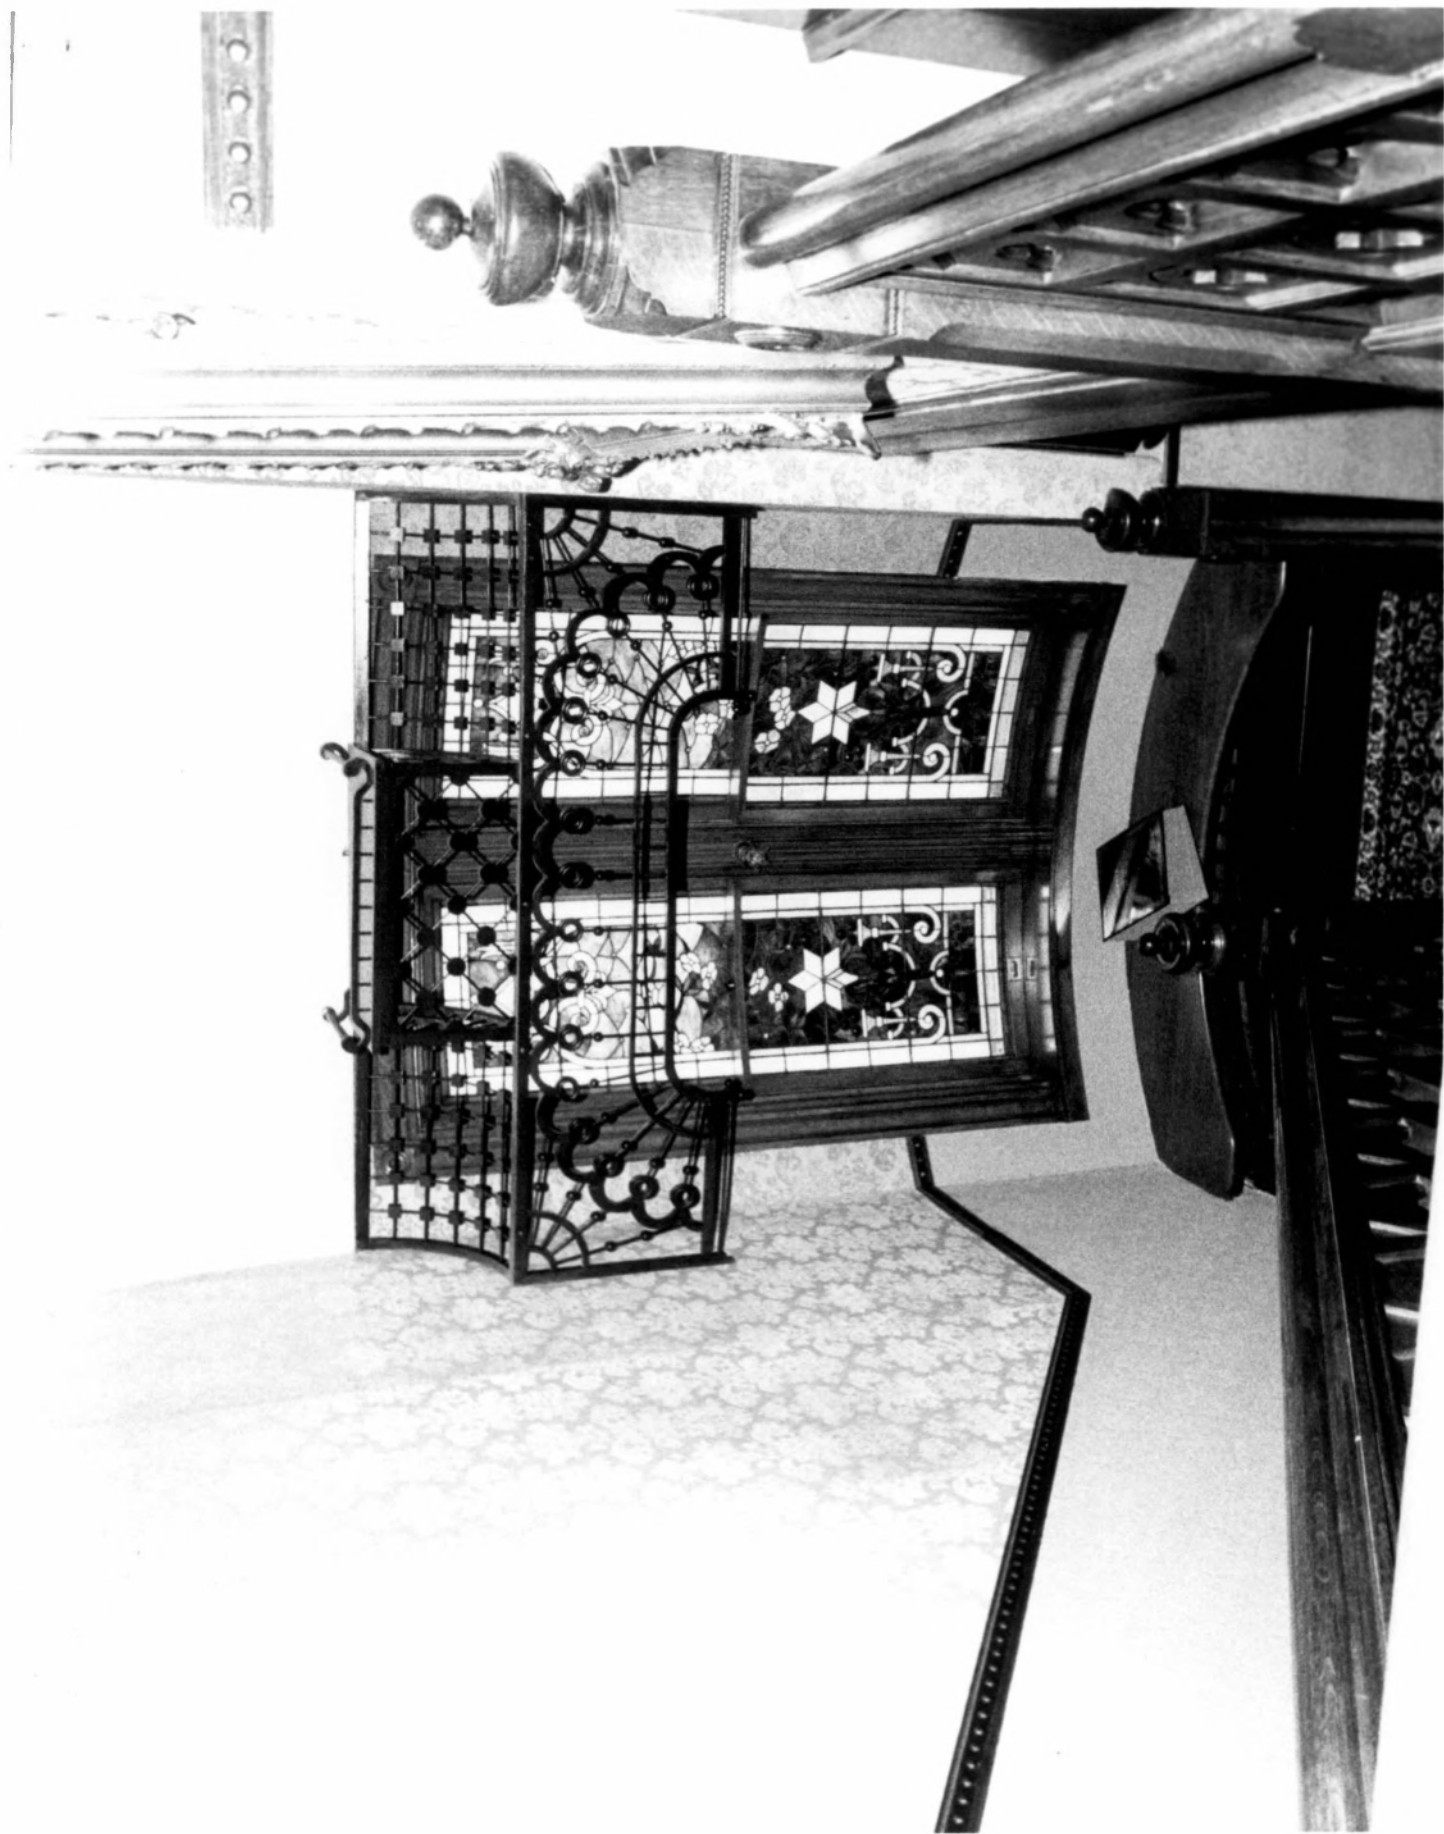
Roslyn Heights
Boonville, Missouri
Maryellen H. McVicker
January 10, 1987
DAR Headquarters at House
Landing in Main Stairway
Photo #11

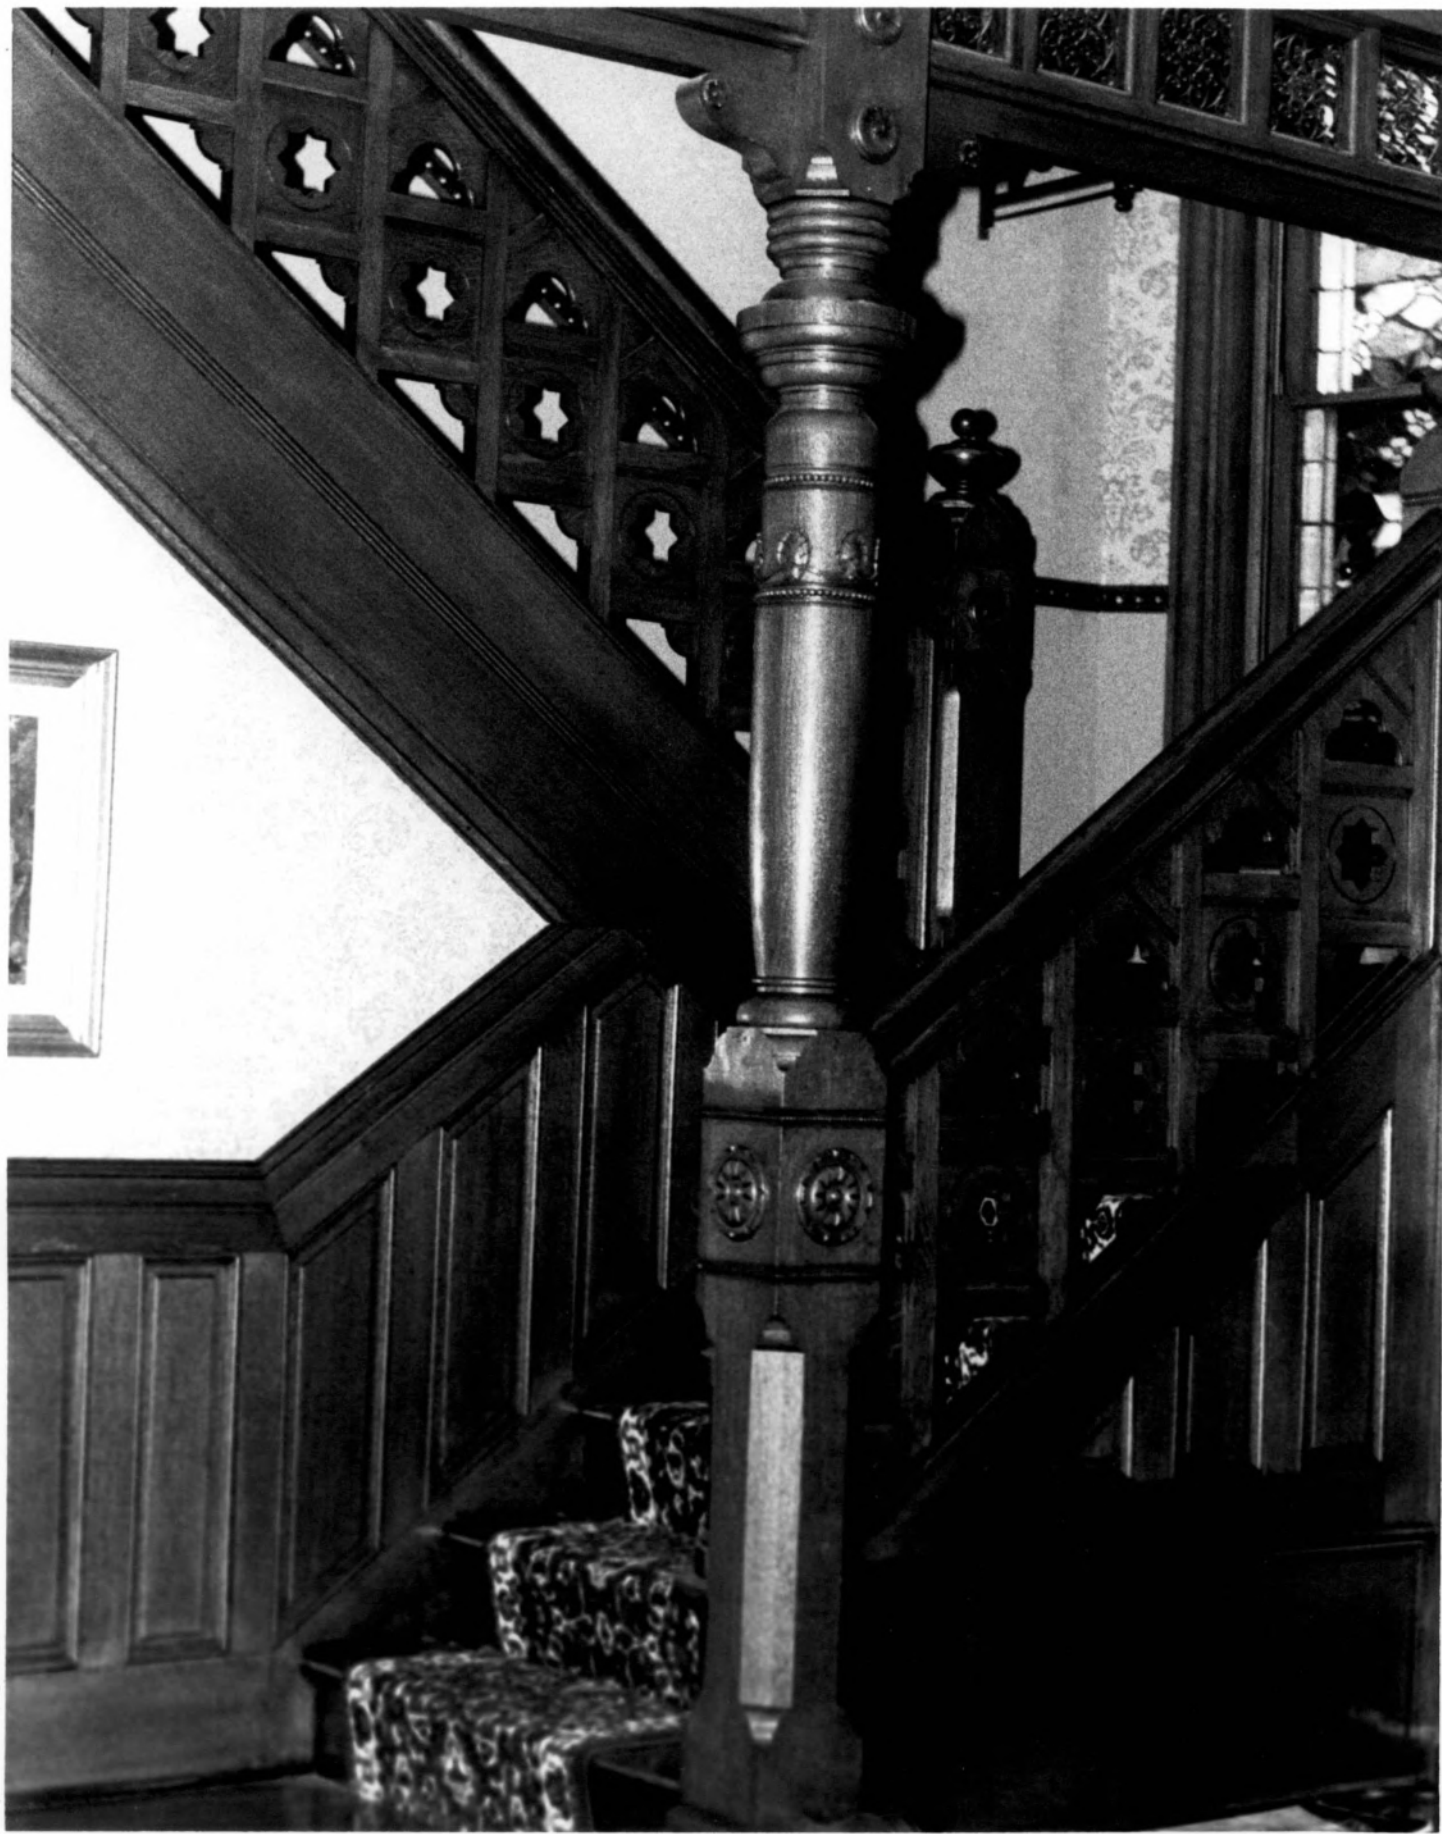
Roslyn Heights
Boonville, Missouri
Maryellen H. McVicker
January 10, 1987
DAR Headquarters at House
Main Stairway
Photo #12

repeats the Moorish details (stars and moons) found elsewhere in the house. A fireplace of oak with unusual rope columns and an ornate mantel shelf is located next to the staircase. An embossed lion's head is behind the swinging coal basket, the only one of this type in the house. Each of the eight fireplaces in the house feature a different color tile around the firebox which sets the tone for the room. Each mantel is also different. The shape of the stairs is both functional and elegant. Built in a geometric design, the stairway features built-in seats at the base and landing where there is a large stained glass window with another oak spindle frieze canopy. Stamped medallions in the newel posts and the cutout motifs on the balustrades are also typical of the period. The dado of the reception hall and staircase have lincristo walden, a pressed paper. A chair rail with brass buttons on a miniature hobnailed background complete the decoration. All doors throughout the house are solid wood and all hinges are sculptured brass. Three sets of pocket doors divide each of the main rooms on the first floor. Hardwood floors are found throughout the house.

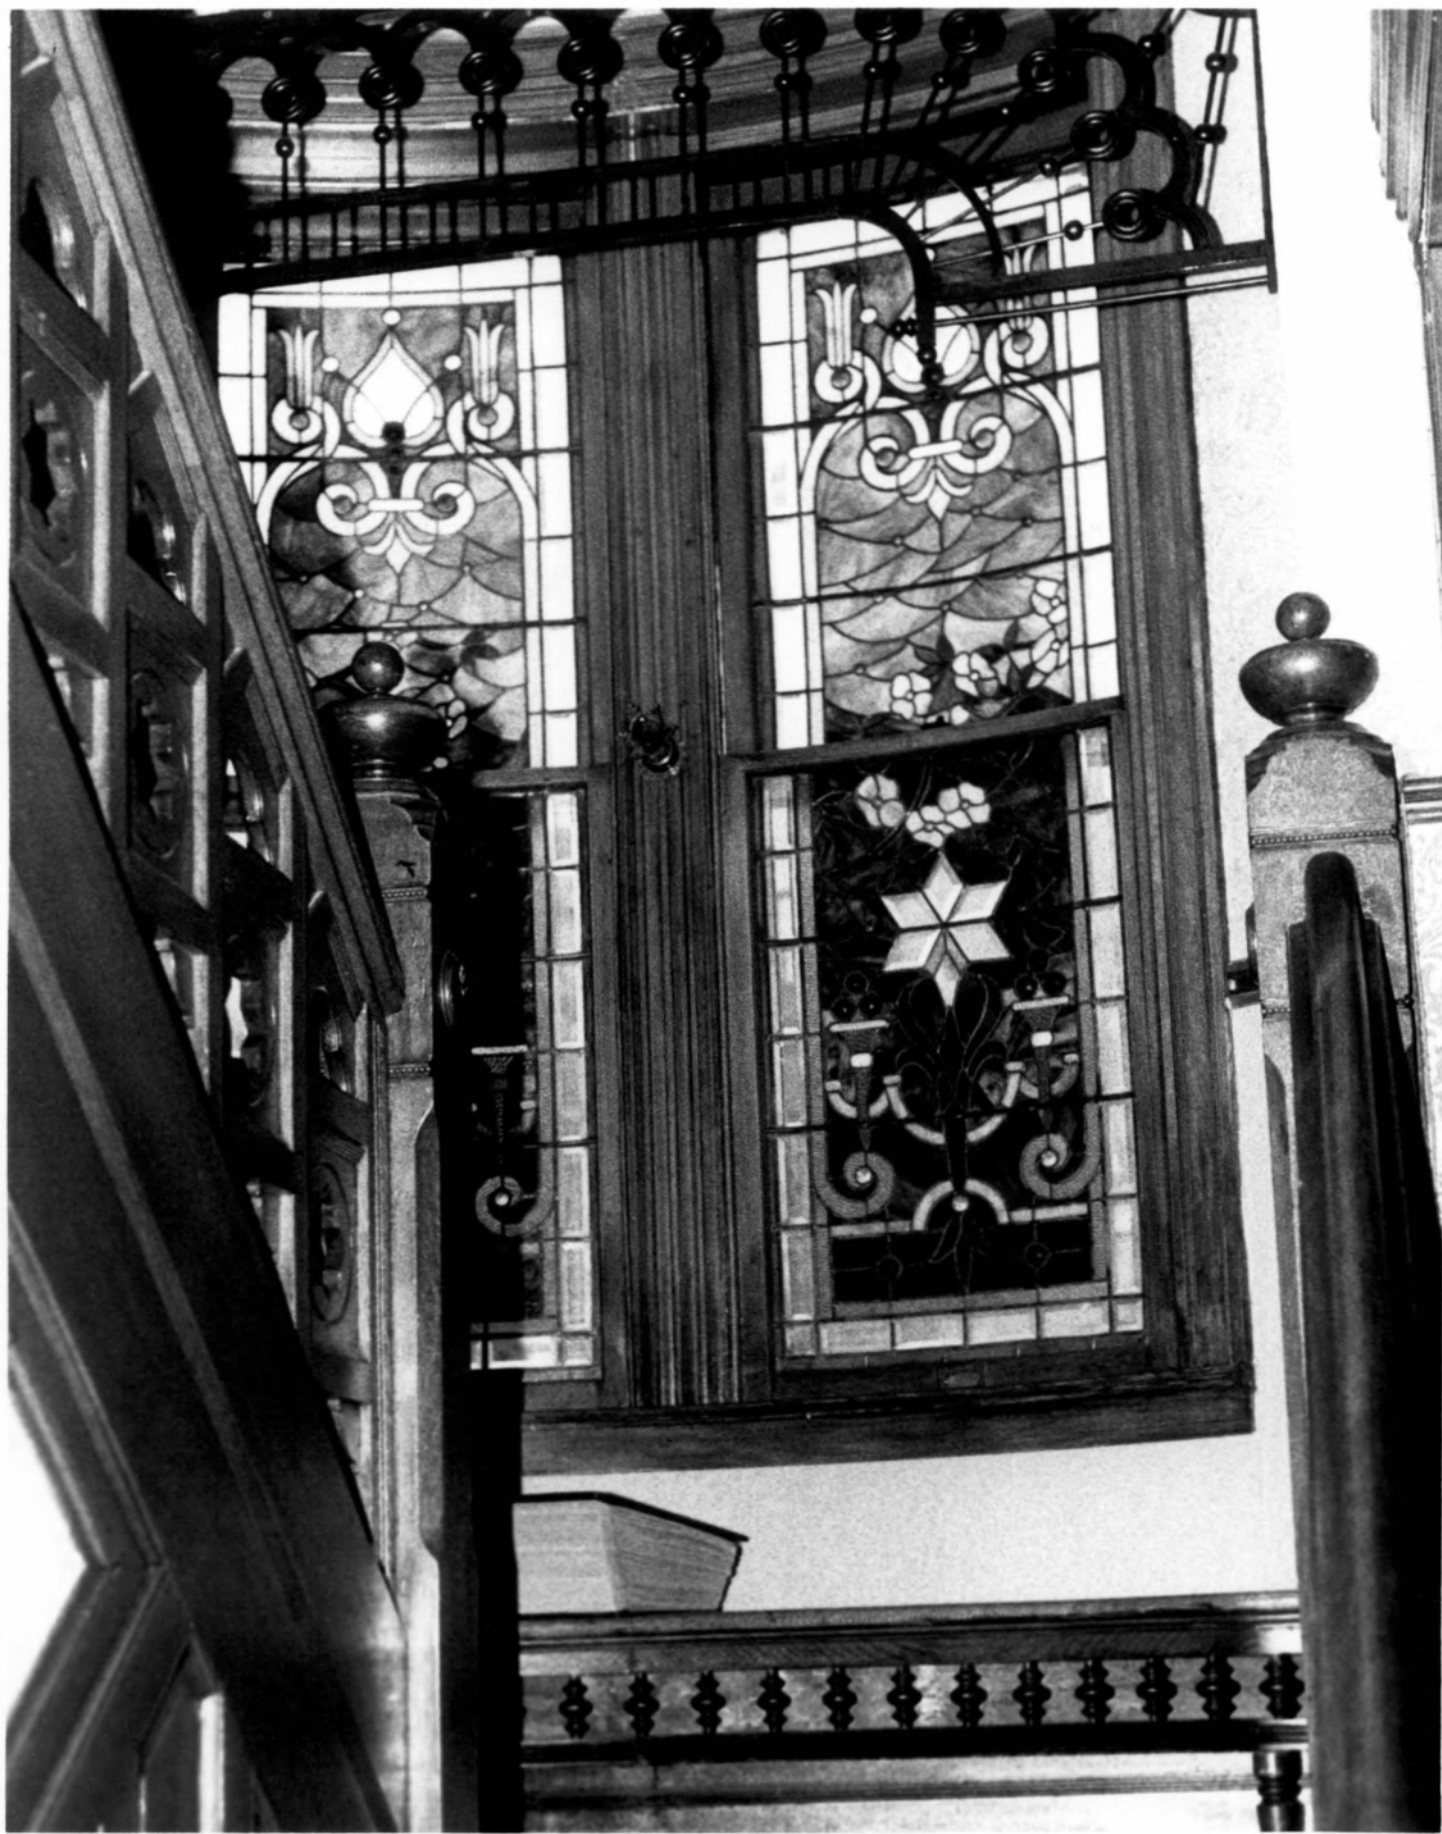
Roslyn Heights
Boonville, Missouri
Maryellen H. McVicker
January 10, 1987
Stained Glass in Main Stairway
Photo #13

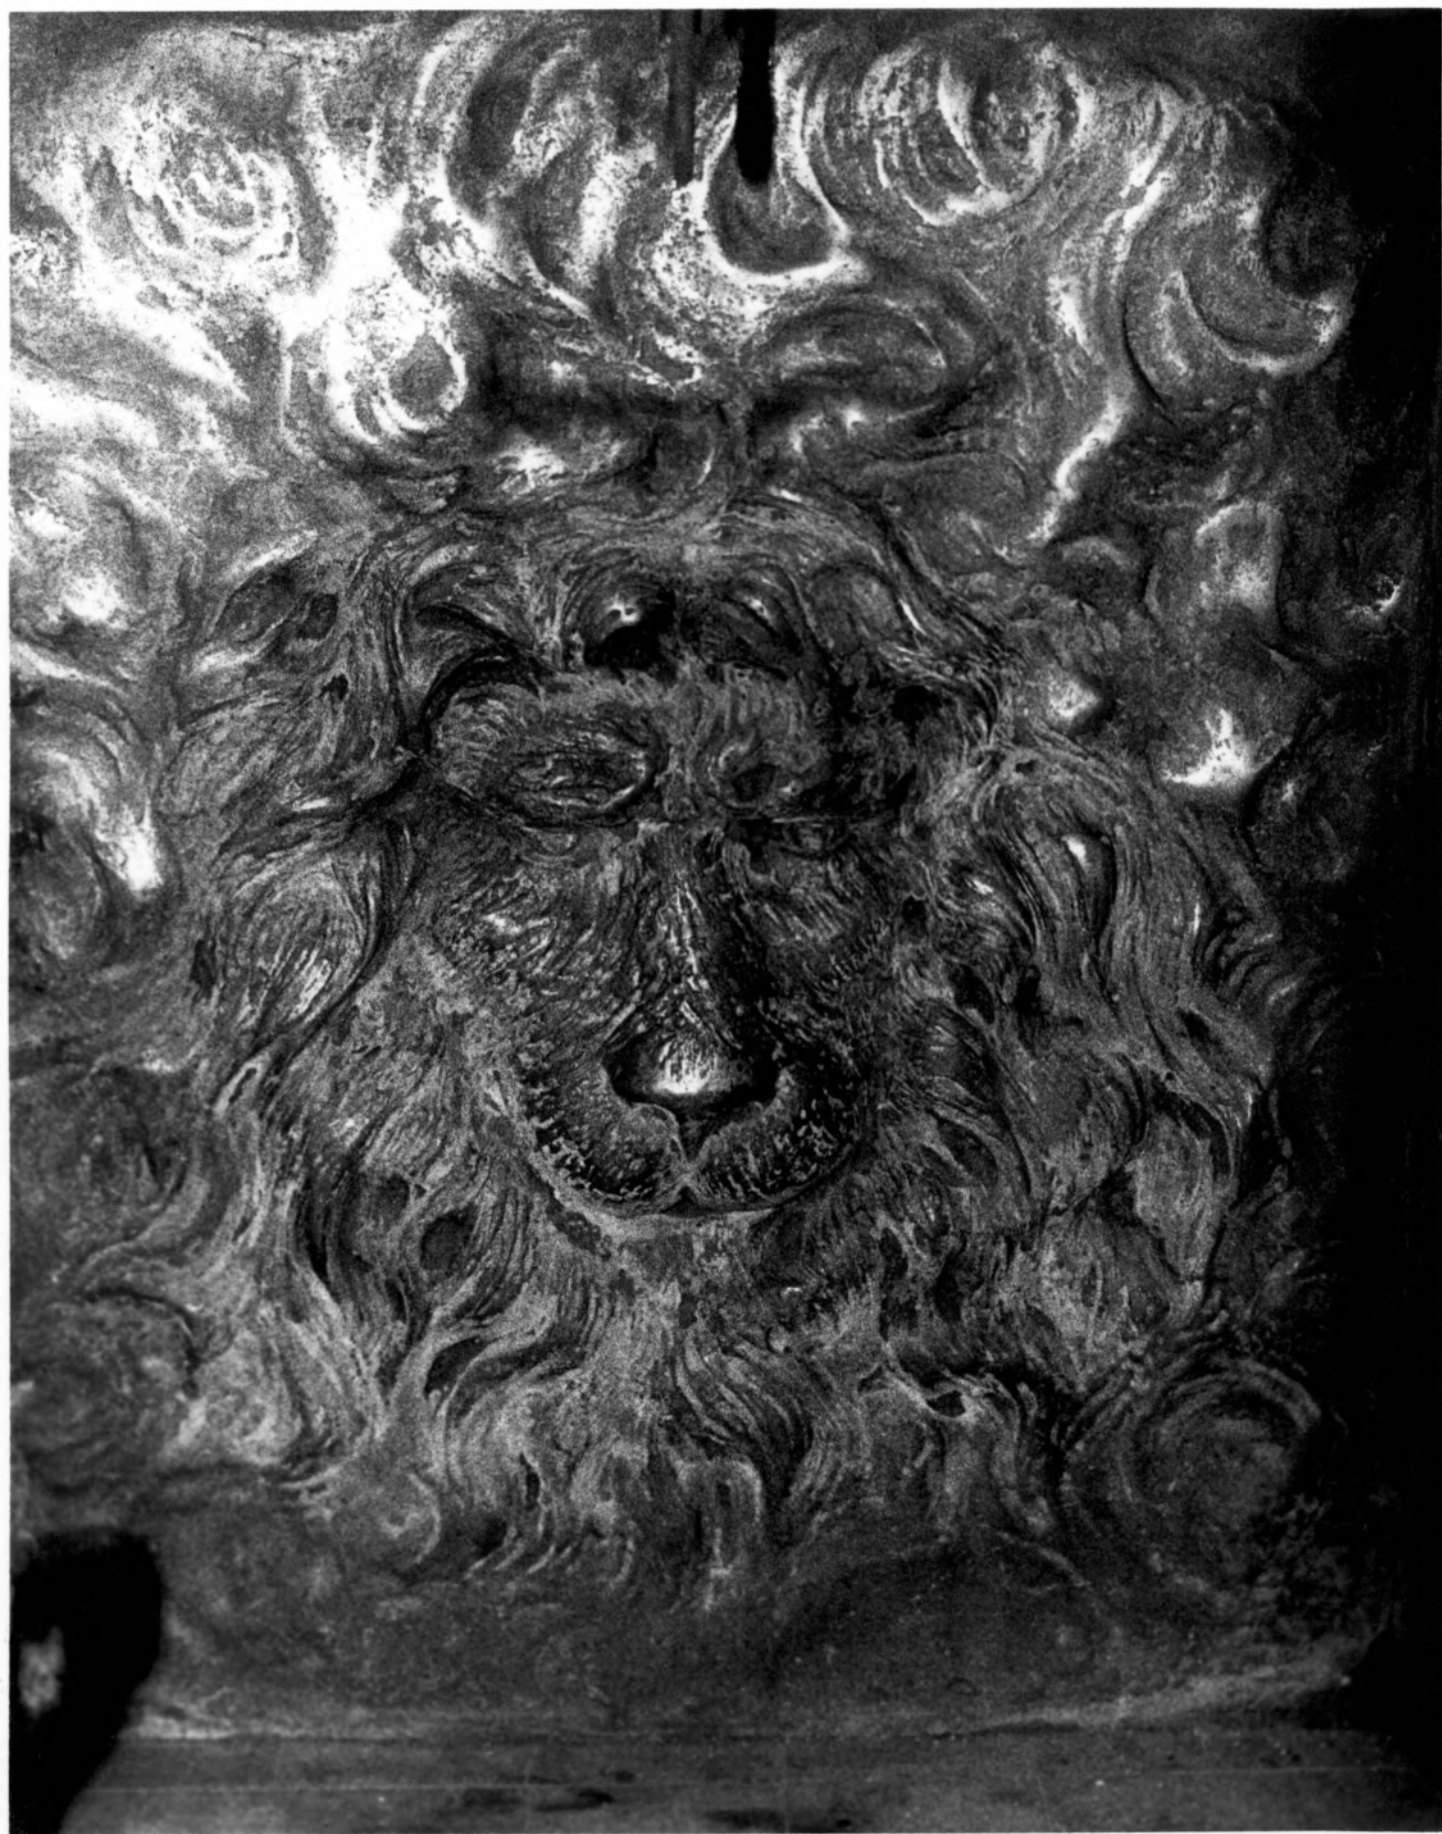
Roslyn Heights
Boonville, Missouri
Maryellen H. McVicker
January 10, 1987
DAR Headquarters at House
Detail--Lion Head Back of
Fireplace

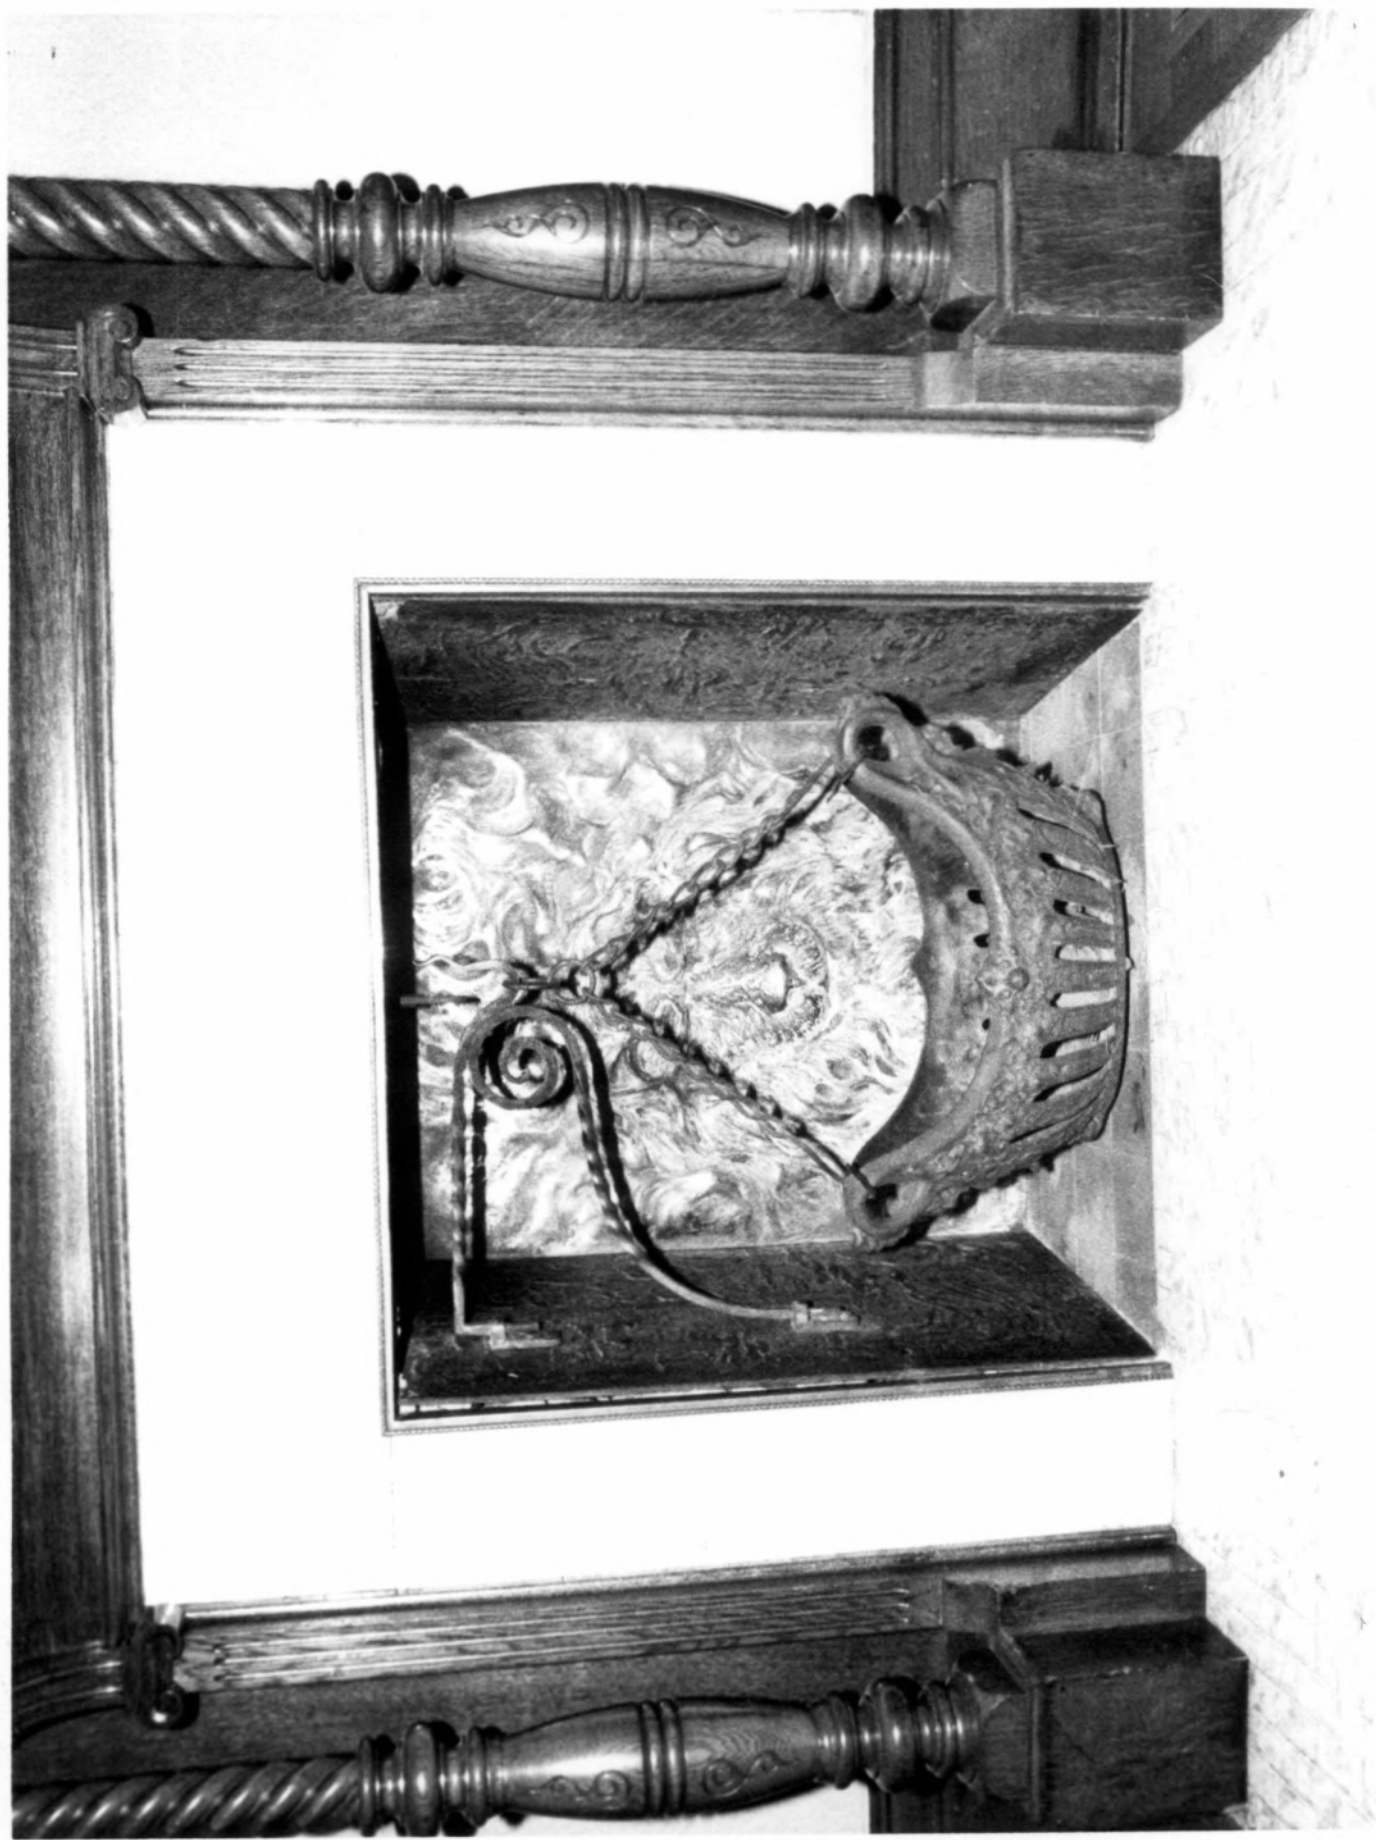
Roslyn Heights
Boonville, Missouri
Maryellen H. McVicker
January 10, 1987
DAR Headquarters at House
Detail--Fireplace Basket in
Entrance Hall

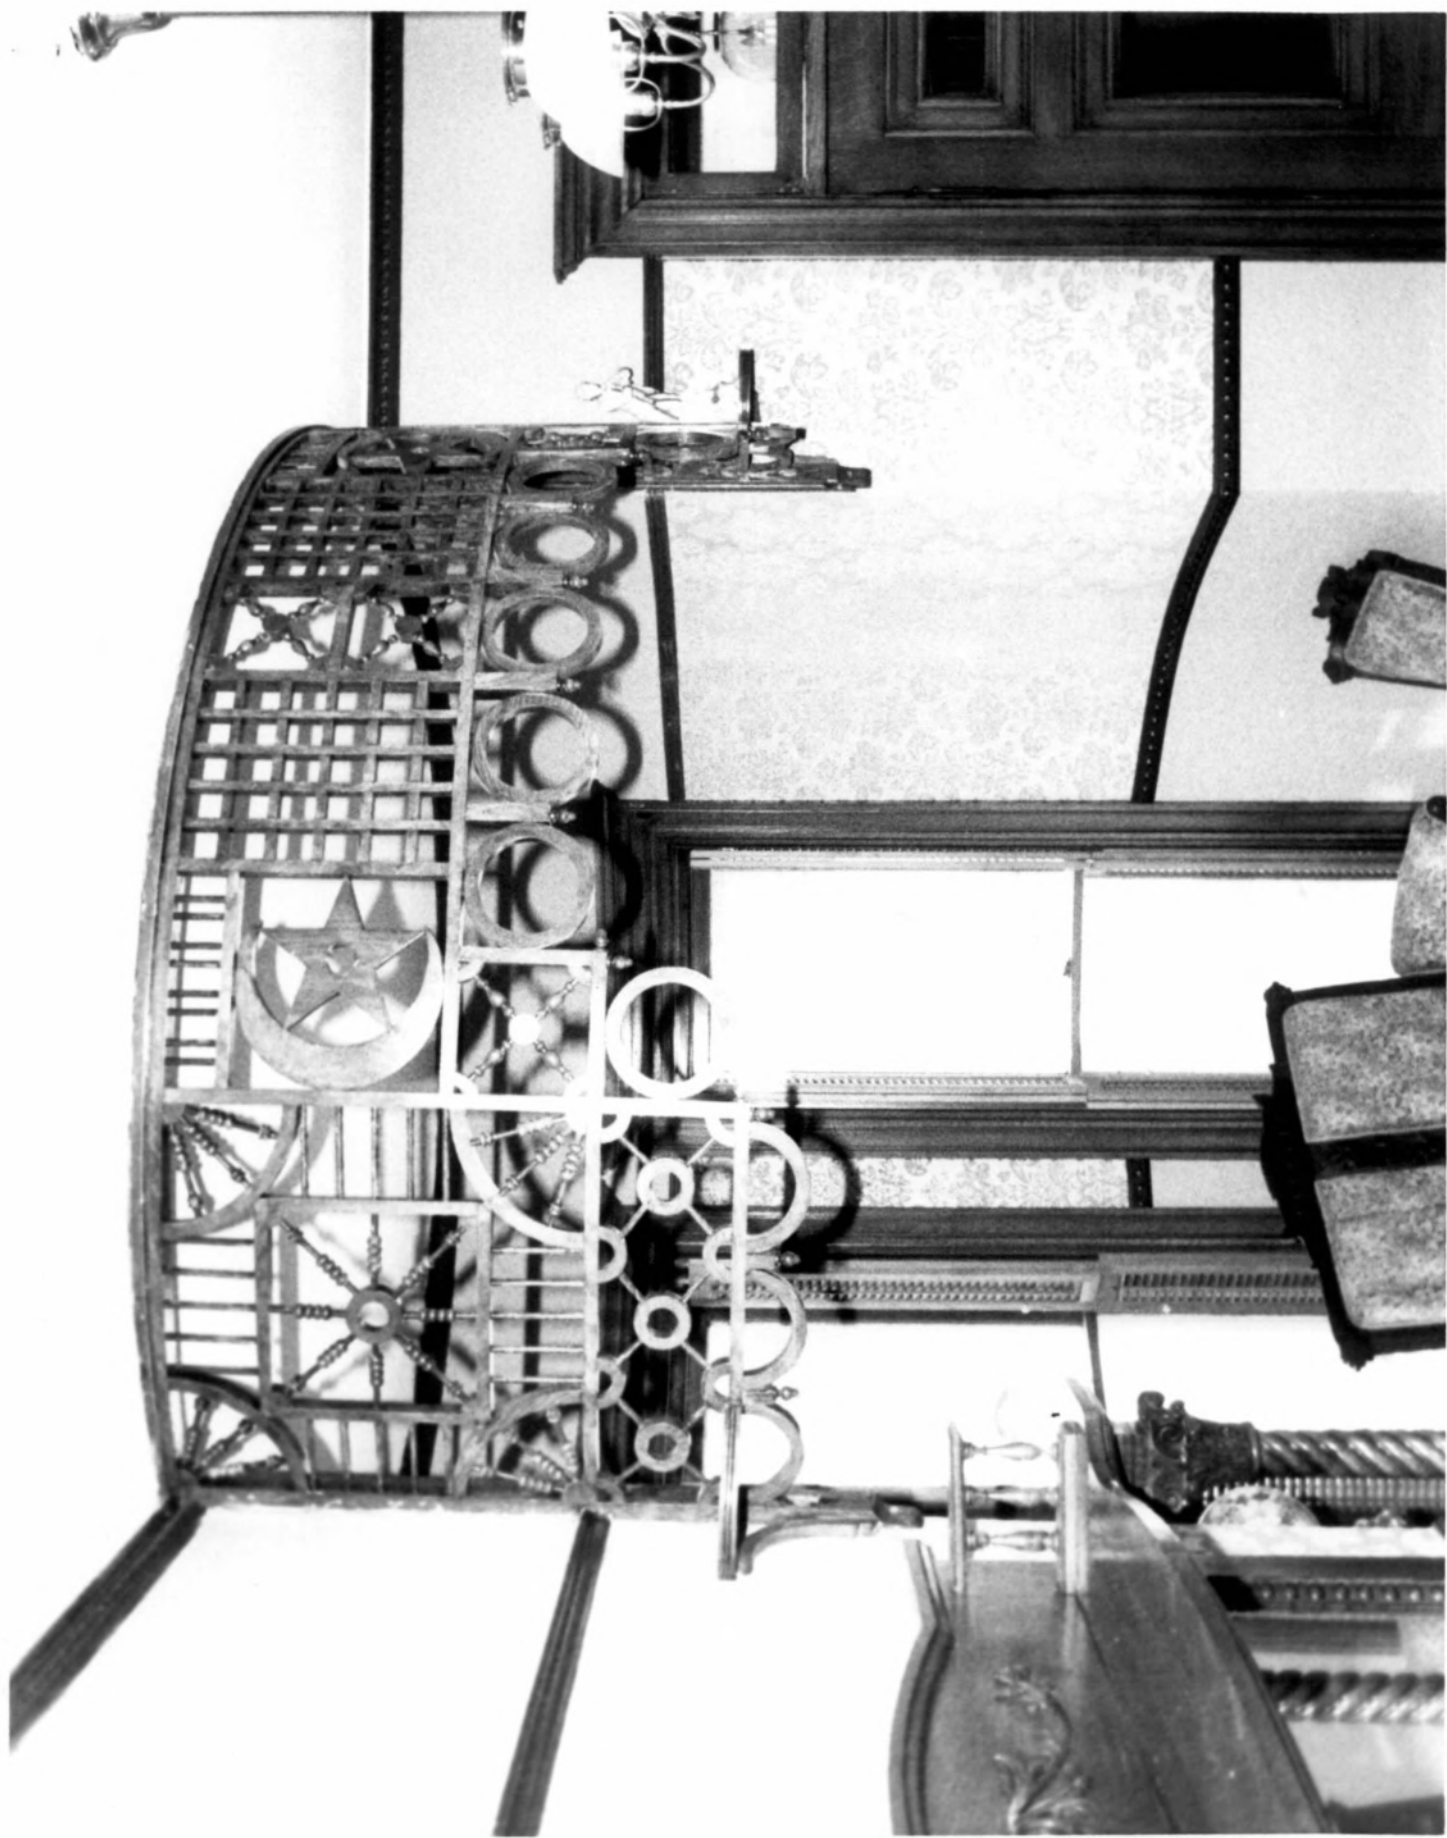
Roslyn Heights
Boonville, Missouri
Maryellen H. McVicker
January 10, 1987
DAR Headquarters at House
Canopy in Entrance Hall
Photo #16

The reception hall has a semi-circular bay that is the base of the tower. The attenuated windows have a trabeated millwork entablature. A spindle frieze canopy highlighting this area is a product of the Industrial Revolution and

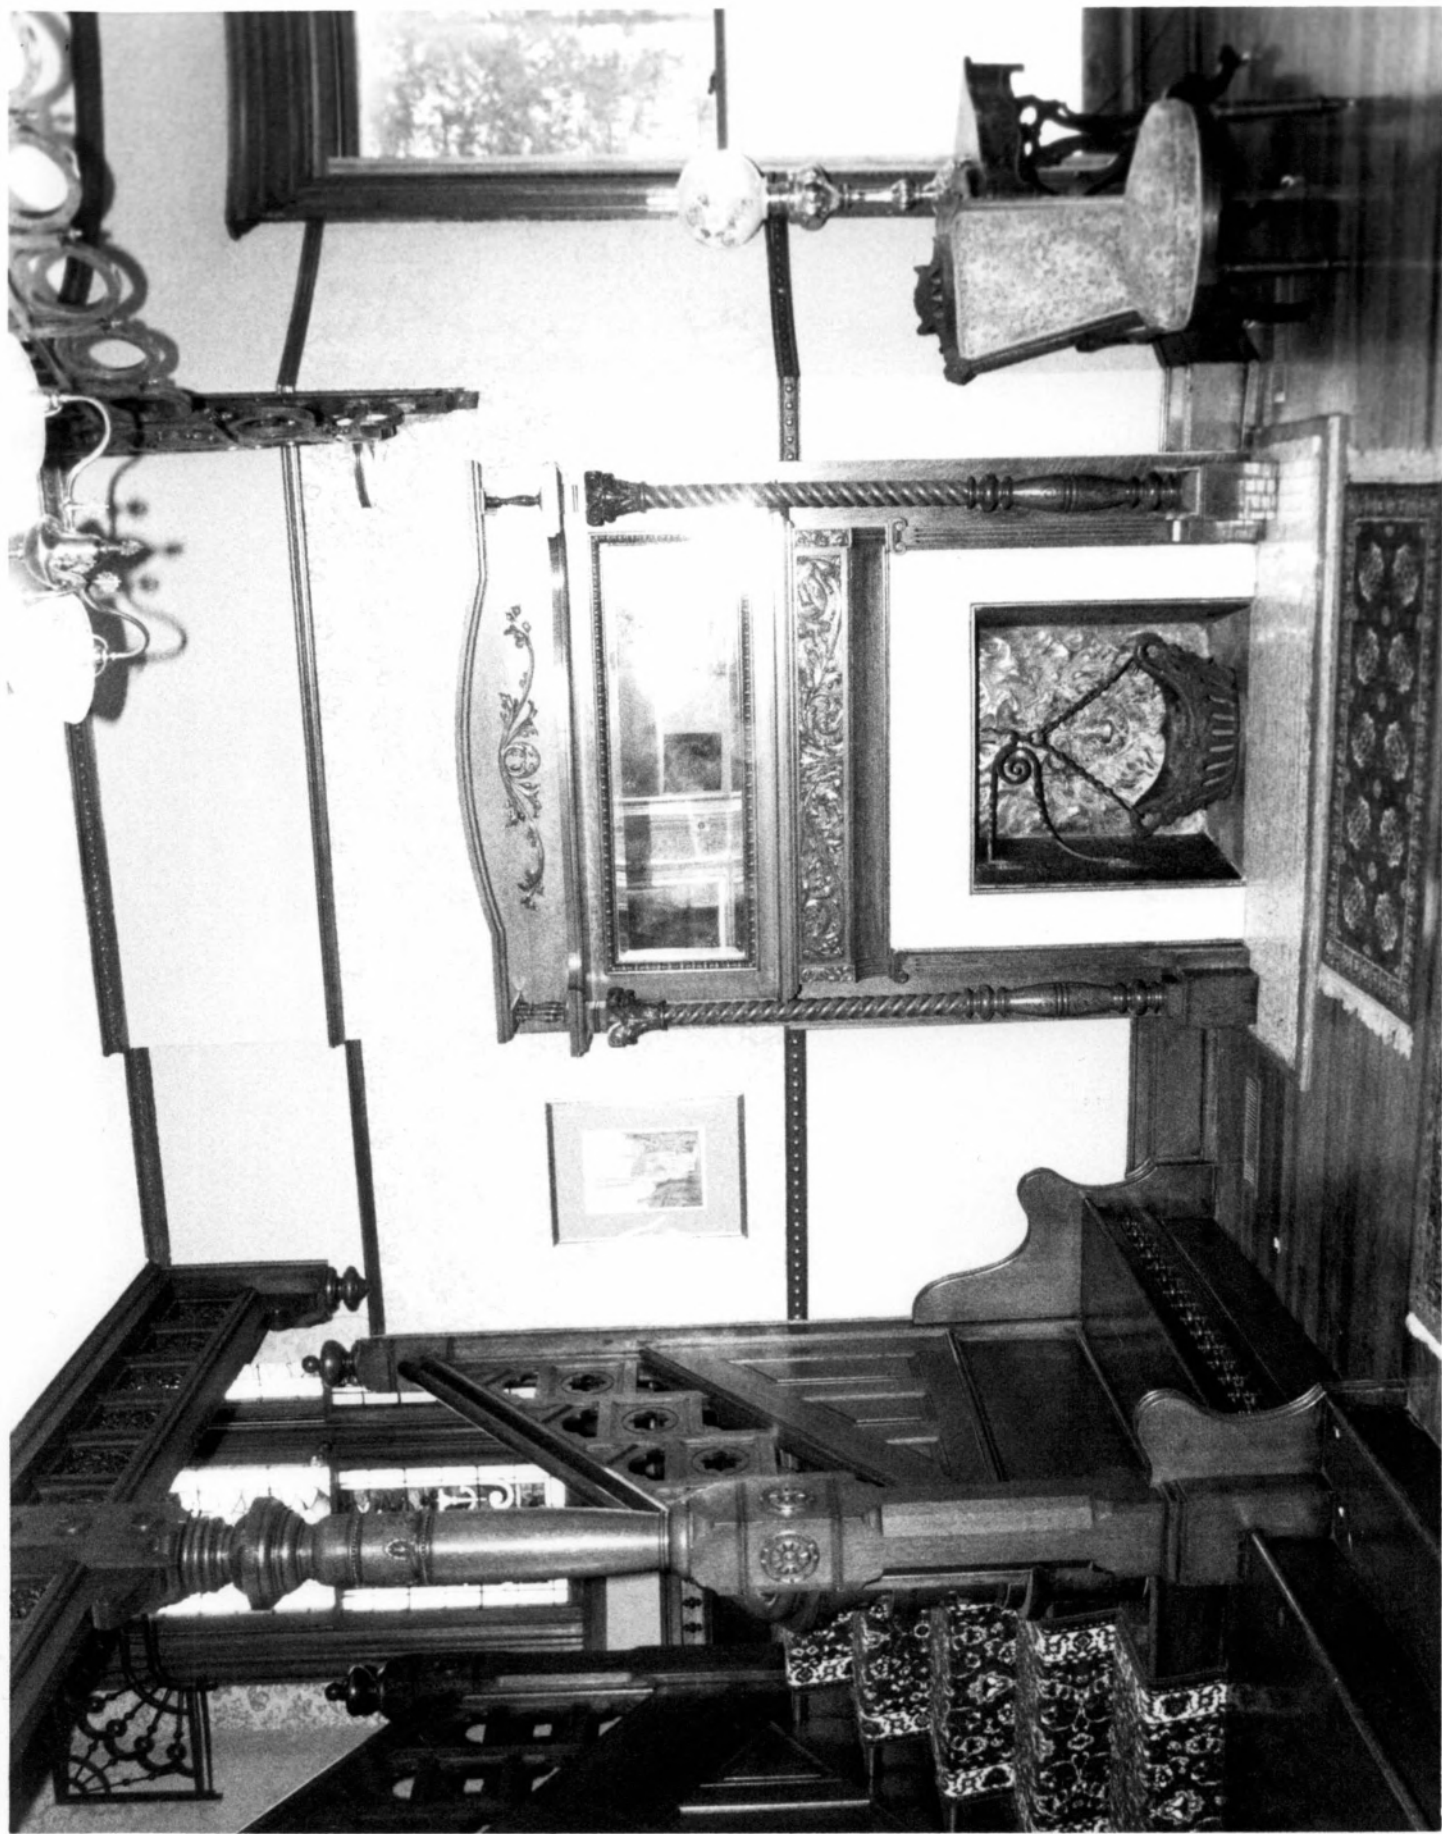
Photo #17

Roslyn Heights
Boonville, Missouri
Maryellen H. McVicker
January 10, 1987
DAR Headquarters at House
Entrance Hall

decorative floor tile and an oak grained wall treatment simulates paneled walls. The gasoliers on the porch are original. The modified Doric composition of the porch is accented by Doric pilasters, gutae, and a severely plain entablature and pediment. The three bay second story features plain brick windows and common bond brick; the east elevation's major decorative accents are found on the first and third stories. Three part windows with arcaded headers accent a third floor dormer while windows on the third floor of the facade tower are capped by stone in a sunburst design.
